MUNICIPAL INFRASTRUCTURE AND IDP HOUSING REHABILITATION PROJECT

CONCEPT STUDY – A PROPOSED USAID FUNDED NEW IDP HOUSING SUBPROJECT

22 MAY 2012

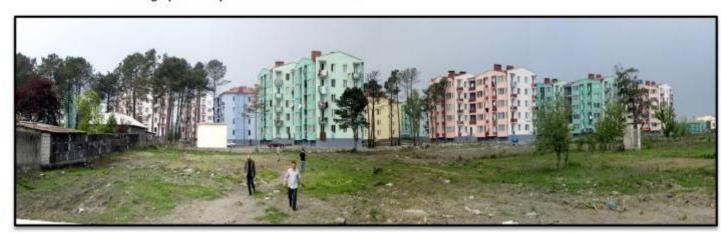
Photograph 4: Existing Poti 32 IDP Blocks: Looking to the Northwest, at the existing IDP Building Site. The green area in the foreground is the new government owned land for the five new IDP Blocks. This photo was taken while standing on the main Poti Highway. The site is flat, with a high water table but the ground appeared to be mostly well compacted undisturbed earth.

Photograph 5: Existing Kutaisi Government Owned Land: Looking to the Northwest from the Main Road. Note the abandoned Tractor Factory to the right. The green area is the land owned by the government. The site is flat, appears well drained, and made up of undisturbed earth
